FATIGUE DAMAGE AND A TRAFFIC ACCIDENT

J. L. Otegui, J. C. Belmonte

INTEMA, University of Mar del Plata, J.B. Justo 4302, 7600 Mar del Plata, Argentina.
jotegui@fi.mdp.edu.ar

The engineering forensic analysis of a traffic accident involving a truck and a bus is presented. Fractographic, metallographic and mechanical studies and numerical models of load transfer and crack propagation were made. A mechanical failure due to fatigue crack propagation was the immediate cause of the accident. However, a series of other factors contributed to the accident, which are also discussed.

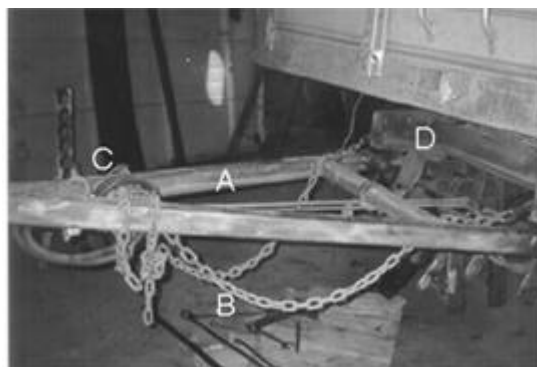
Figure 1. Front view of trailer: lance (A), safety chains (B), brake hoses (C), and rotating platform (D) of the front (steering) axle

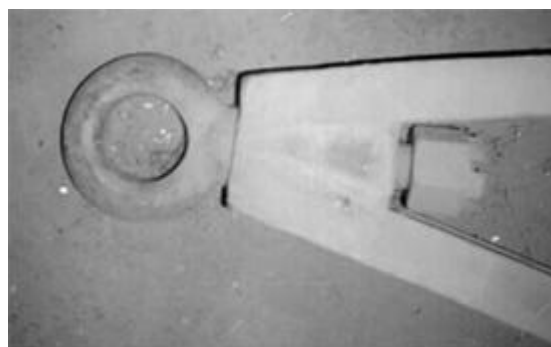
Figure 2. Buttonhole and bolt assembled to the trailer lance. The buttonhole is connected to the tractor mooring hoop.

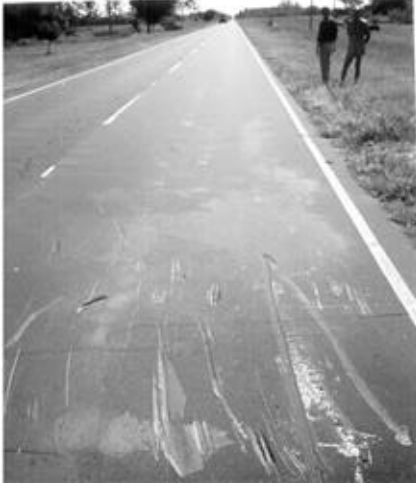
Figure 3. Overview of the two lane road at the crash site The marks in the pavement indicate the place where bus and trailer impacted.

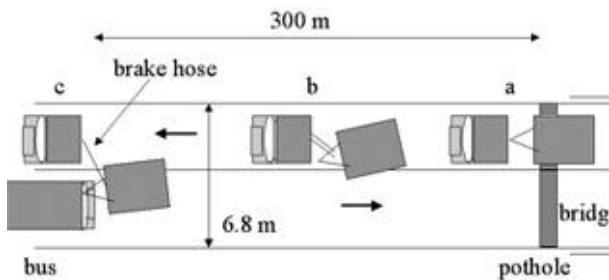
Figure 4 Sketch of the area of the accident. (a) buttonhole bolt breaks after crossing the bridge, (b) safety chains break, (c) bus and trailer crash.

Field observations allow to conclude that the fracture of the bolt linking the tractor and the trailer took place when the trailer stepped on a pothole in the route, at the exit of the bridge (position "a", figure 4). The tractor kept pulling the trailer through the safety chains (figure 1), for about 200 meters, until the chains also broke. (position "b"). After the fracture of the safety chains, the trailer invaded the opposite lane, and was impacted by an incoming bus (position "c"). Bad fortune was important in this accident. If the crossing between truck and bus had happened 200 meters later, the bus driver would have had time to see the trailer in his own lane and carry out some evasive maneuver. In this case, a possible human error can not be attributable to the drivers of the vehicles at the moment of the accident, but more probably to those responsible for

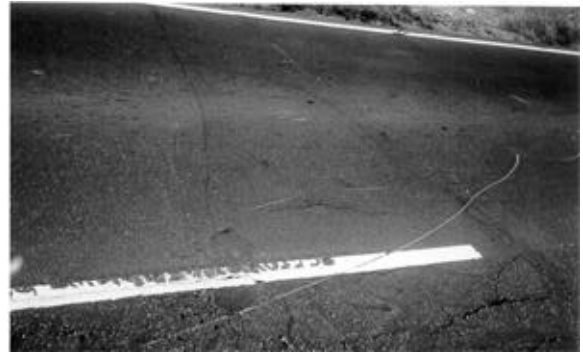
Several marks on the pavement revealed interesting aspects of the accident. These marks correspond fundamentally to the lance of the trailer and to diverse parts of the chassis of both vehicles during the collision. Two areas are observed: 1 to 5 mm deep semicircular scratches, of 1 to 2 metre radii, that begin in the truck's circulation lane, and cross the central line of the route. These marks, shown in **Figure 5**, are due to the haulage of the lance onto the pavement. The lance shows indications of having been deformed by compression, see **Figure 6**. Bright scratches found in the lance tip also confirm this evaluation. The semicircular marks shown in figure 5 end up with other 5 to 20 mm deep marks, parallel to the route, located on the opposite circulation lane. The lance fastener with a broken part of the bolt was found in the bank ten meters downroad from the bridge, see **Figure 7**, while its washer was found about 50 meters from the bridge. A link of the safety chain was found near the place of the crash, on the opposite bank. The retention spring was found broken, still attached to the trailer. A good

Figure 5. Semicircular scratches on the pavement produced by the lance cross the central line of the route.

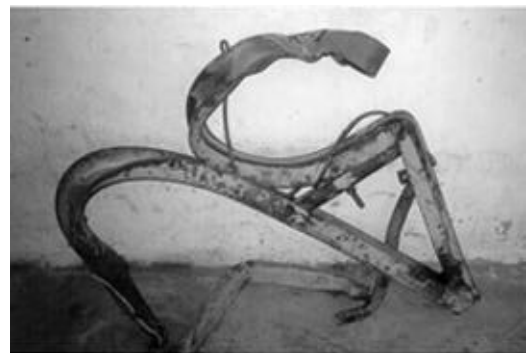
Figure 6. The lance was deformed by compression, bright scratches are found in its tip

Bright marks appear on the lower border of the left bar of the lance bar shown in figure 6. These marks were produced by contact with the safety chains of the trailer. This indicates that the safety chains were located in crossed position. This disposition presents advantages and inconveniences over the normal parallel disposition of the chains. As possible advantages, they are necessary to retain the lance in the event of a fracture of the hook and retention spring, because when the chains are being tightened the lance remains horizontal. The crossing point of the chains works as a rotation point. In the common parallel disposition, the fracture of one of the chains produces a very small moment over the trailer toward the opposite side. In the crossed disposition the trailer rotates toward the side of the chain which fractures first. In our case, the right chain broke first, and then the trailer was dragged by the left chain for a short time, leaving the marks when being tightened. This generated a turn of the trailer toward the left, its entrance in the contrary lane and its impact with the bus.

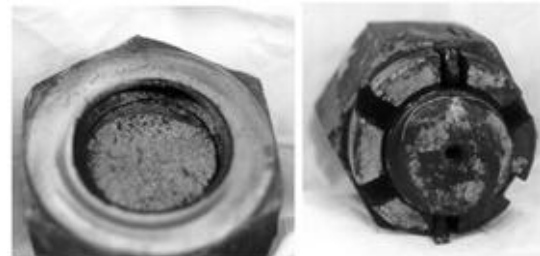
Figure 7. The lance fastener with a broken part of the bolt, found in the bank ten meters downroad from the bridge.

Figures 7 and 11 show the two fracture surfaces of the bolt within the first thread inside the fastener. The fracture is clearly defined as initiating from a defect at the inside of the thread. The fracture bears a certain degree of plastic deformation, indicated by the torn ligament in a sector of about 90° (lower part of figure 11) . This torn sector corresponds to the final separation of the two parts of the fractured bolt. The surface of the fast fracture is of mixed type, with sectors of fibrous appearance (fracture by ductile microvoid coalescence) and sectors of crystalline appearance (fracture by cleavage). These characteristics are typical of a fracture above the ductile – brittle transition temperature of the material ^[8]. The Chevron marks show that the propagation of the fracture took place from top to bottom in figures 7 and 11, this is, it began in an initial crack and finished with the total separation of the material by plastic collapse. This final ligament is clearly identified because in its final stage the fracture followed two different surfaces, corresponding to two consecutive threads.

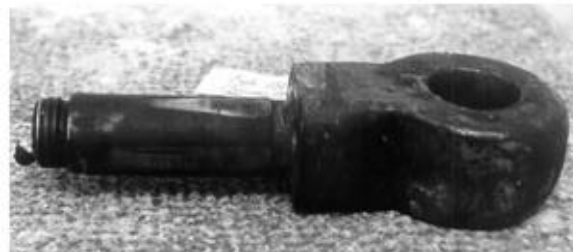
The broken fixation piece is shown in **Figure 8**. It is composed by a buttonhole and a bolt that inserts in a cylindrical lodging inside the lance, to which is fixed by means of a nut or fastener (see figure 7). The traction loads are supported by the nut. The buttonhole itself is a cast steel piece that does not usually receive thermal treatment, which is welded to the bolt. Microstructural analyses of the bolt showed a mostly pearlitic structure, with ferrite as second phase, as shown in **Figure 9**. Scarce tendency to the formation of low toughness microstructures is observed. Widmastatten pearlite - ferrite ratio is around 85/15. Longitudinal banding of the ferrite in grain boundary due to radial deformation during forging is observed. The thread was laminated rather than mecanized, since lines of deformation are not discontinued by the threads [5]. Chemical characterization identified this steel as a SAE 1048. Mechanical and fracture mechanics testing of the material lead to this properties [6]: yield strength 420 Mpa, Ultimate Tensile Strength 680 MPa., Fracture toughness 60 MPa m^{1/2}. The buttonhole is a wrought SAE 1045 material.

Figure 8. Detail of the broken buttonhole and bolt assembly.

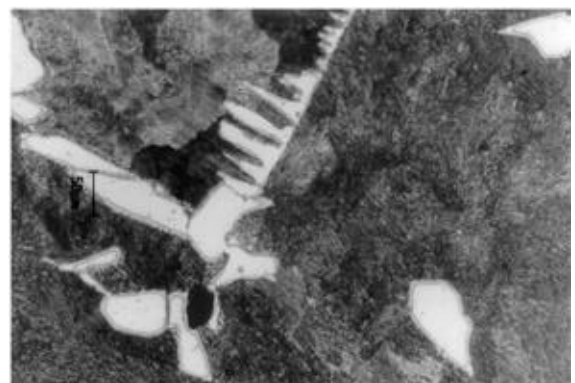
Figure 9. (X200) Microstructure of the wrought SAE 1045 bolt material. Widmastatten pearlite - ferrite ratio is 85/15.

Metallographic observations revealed that the bolt and buttonhole assembly seen in Figure 9 was welded with an austenitic (stainless steel) electrode, of the type AWS 309. Austenitic fillers are used to weld materials of high resistance and low toughness, like the SAE 1045. Hydrogen cracking

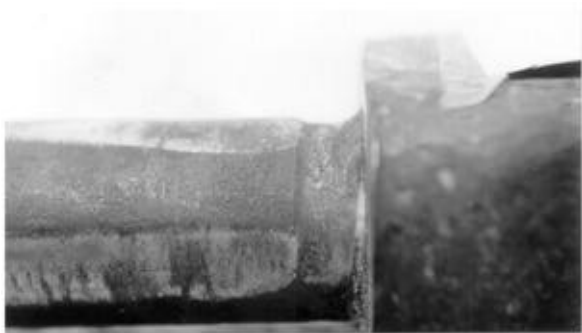
problems, common in these types of hardenable steels, are in this way minimized. On the other hand, austenitic weld metal presents low resistance to wear ^[7]. **Figure 10** shows high premature wear in the welded area. The bright surfaces in the sides of the bolt indicate that it slipped against the walls of its lodging in the lance. From these marks, it was estimated that a gap of 8 mm existed due to incorrect adjustment of the nut of the fastener (exemplified in figure 2).

Figure 10. Evidence of high premature wear in the buttonhead to bolt weld, due to friction against the walls of its lodging in the lance.

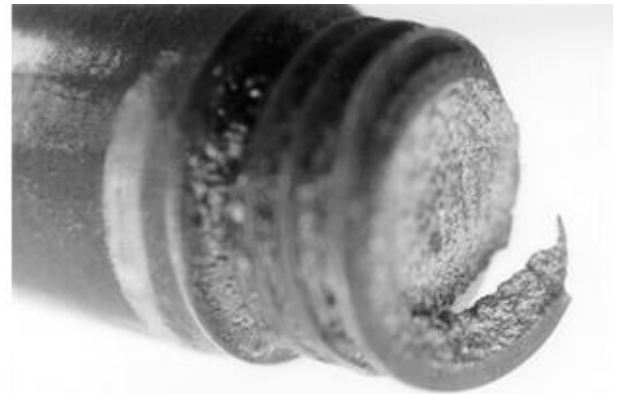
Figure 11. Fracture surface in the bolt . Note initiating defect within the first thread inside the fastener, and ligament torn by final plastic collapse.

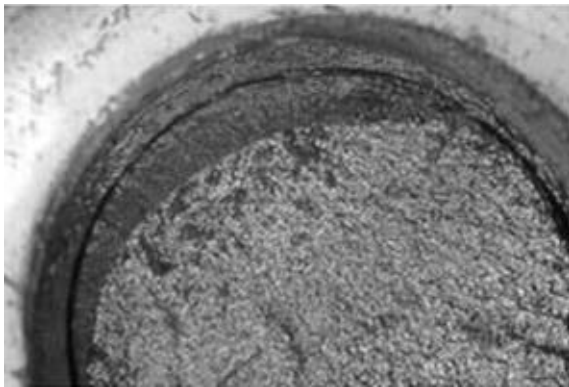
Figure 12 shows that initiation of the fast fracture takes place from a half penny shaped crack, about 3 to 3.5 mm deep around 120° of the perimeter of the bolt. The shape of the crack and its smooth surface in this region are typical of low cycle fatigue crack growth due to tensile loads ^[4,5,8]. Initiation of the crack is not associated to a single defect, such as a corrosion pit, an inclusion, etc., but rather to the stress and strain concentration due to the geometry of the thread. Therefore, it is concluded that the fatigue crack was not related to material or fabrication defects, but rather to high cyclic loads during service.

Figure 12. Fracture initiation from a half penny shaped 3.3 mm deep fatigue crack.
